NASA Contractor Report 159267

1. Report No. NASA CR-159267	2. Government Accession No.	3. Recipient's Catalog No.	
4. Title and Subtitle Time-Temperature-Stress Capabilities of Composite Materials for Advanced Supersonic Technology Application - Phase I		5. Report Date April 1980

6. Performing Organization Code	
7. Author(s) J.R. Kerr and J.F. Haskins		8. Performing Organization Report No. GDC-MAP-80-001	
9. Performing Organization Name and Address Convair Division of General Dynamics Corporation 5001 Kearny Villa Road San Diego, California 92123		10. Work Unit No.

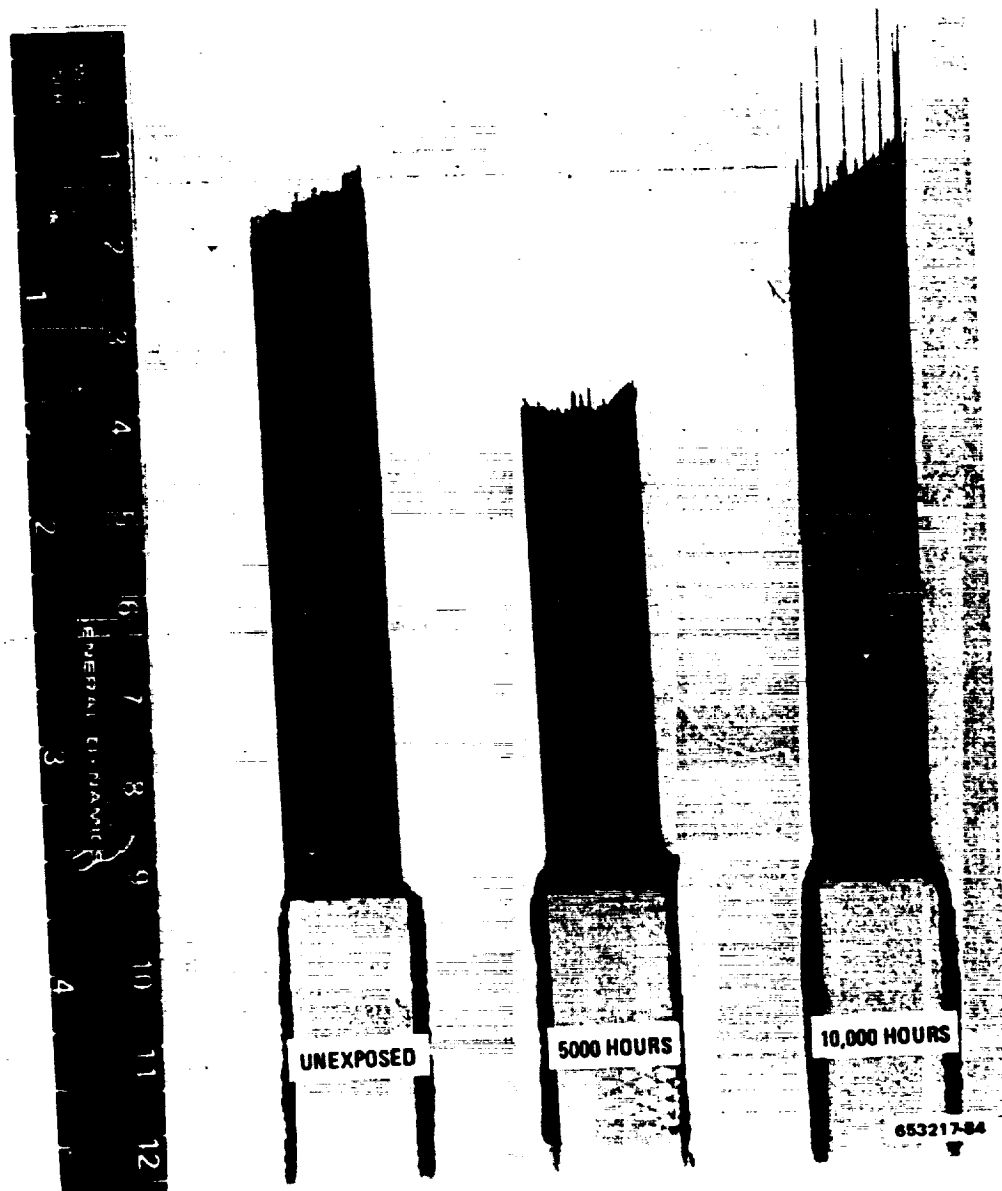
Figure 8-13 B/E Before and After Thermal Aging at 450 K (350° F) in 0.014 MN/m² (2 psi) Air and Tensile Testing at the Same Temperature

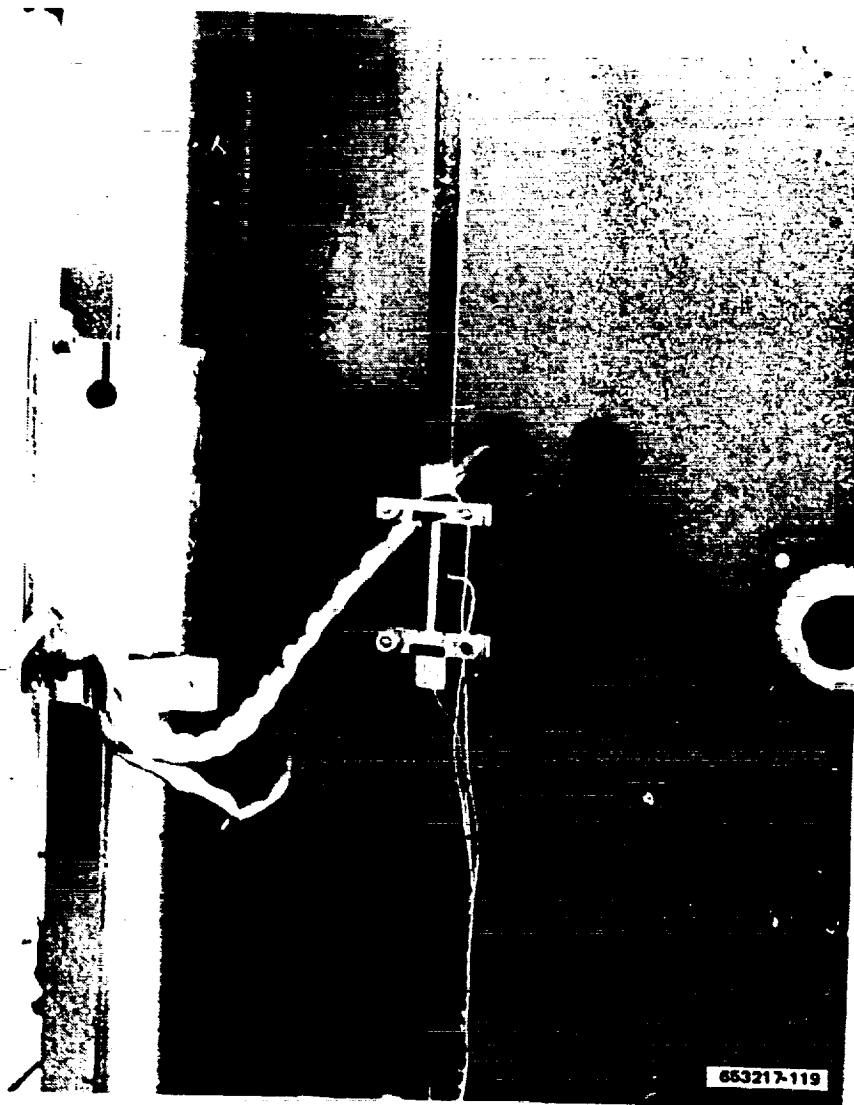
Figure 10-4 Creep Specimen with Platinum Sliding-Strip Extensometer and Thermocouples Attached
